Aviation Investigation Final Report

Location:	Hydro, Oklahoma	Accident Number:	CEN24FA094
Date & Time:	January 20, 2024, 23:23 Local	Registration:	N295AE
Aircraft:	Bell 206	Aircraft Damage:	Destroyed
Defining Event:	Birdstrike	Injuries:	3 Fatal
Flight Conducted Under:	Part 135: Air taxi & commuter - Non-scheduled - Air Medical (Discretionary)

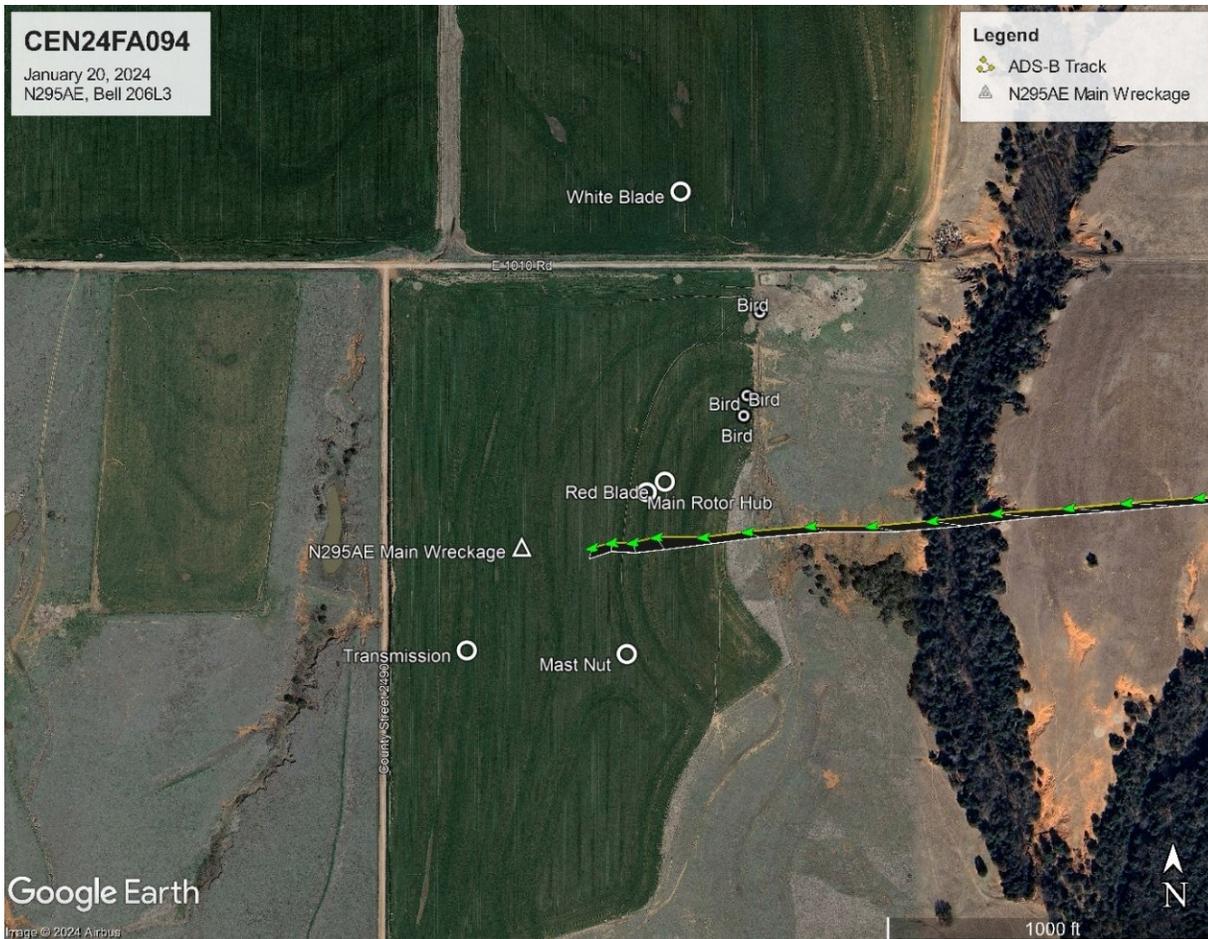
Figure 1. ADS-B Flight Track with Wreckage and Bird Locations

ADS-B data captured the accident flight as it departed OL16 and flew west towards OL16 between 500 ft and 600 ft above ground level and about 110 knots groundspeed. The last ADS-B point was at 2323:39 about 210 ft east of the main wreckage location (see Figure 1).

The helicopter wreckage was located in a rolling pasture about 6.2 miles east of the destination heliport of 4OK1. The debris field was about 265 yards long and 455 yards wide. All major components of the helicopter were located at the accident site. The main wreckage consisted of the fuselage, engine, and tail rotor. The transmission had separated from the fuselage and was located at the site. The helicopter's main rotor blades had been changed via supplemental type certificate to Van Horn Aviation composite blades. The white main rotor blade was fractured and found in an adjacent field, about 300 yards north of the main rotor

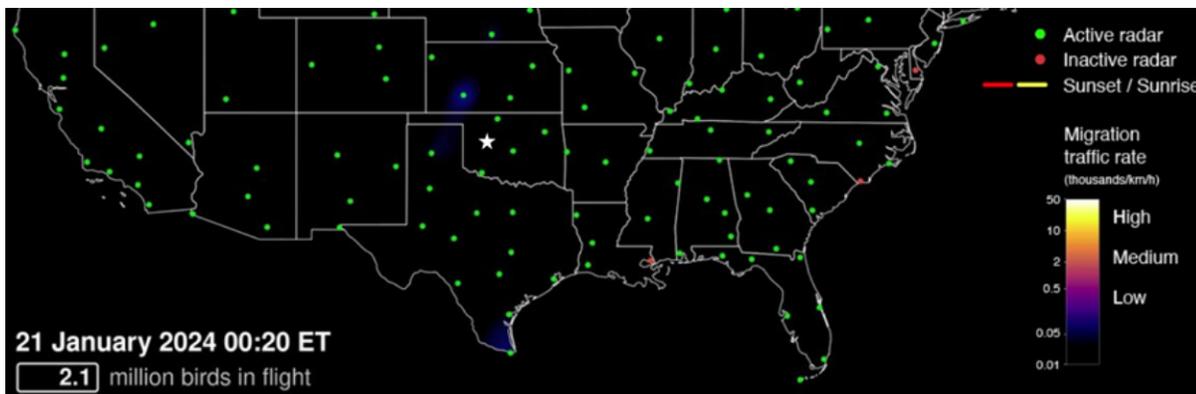
Figure 2. BirdCast Information – Accident location annotated by a white star.

In addition, another bird avoidance resource, BirdCast, uses a collaboration of radar and spotter information to provide near-real-time models of bird activity. A review of historic data contained on their website showed no significant bird activity in the vicinity of the accident (see Figure 2)
